A FULL 3-YEAR WARRANTY

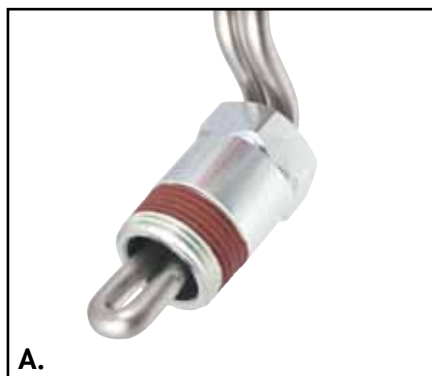
A. Approved claim.

Characteristics: A clean and shiny heating coil that cannot be installed when the vendor visually inspects and/or attempts installation or does not function.

Cause: Manufacturing or material defect.

Advice: Send in only heating coil for claim handling

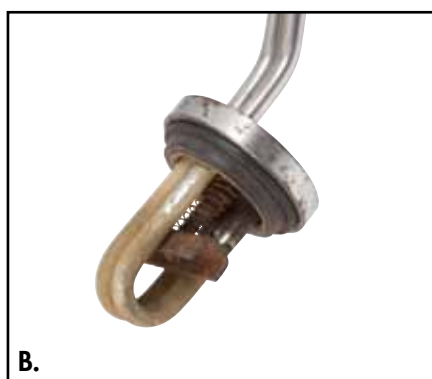
B. Rejected claim.

Characteristics: Coating on heating coil.

Cause: Polluted/contaminated coolant e.g. radiator cement is added to the coolant.

Advice: Clean the cooling system, install a new heating coil according to the installation instructions and fill new coolant.

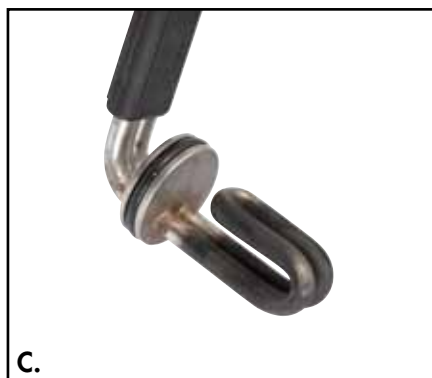
C. Rejected claim.

Characteristics: Completely or partly blue-black heating coil.

Cause: Insufficient cooling of heating coil as a result of:

1. Incorrect installation (see installation instructions).
2. Insufficient bleeding of air from cooling system (see vehicle 's owner 's manual).
3. Insufficient coolant in cooling system (see vehicle 's owner 's manual).
4. Insufficient quantity of anti-freeze in cooling system (icy slush prevents circulation)
5. The heater is connected to intermittent (pulsing) voltage

Advice: Install new heating coil according to installation instructions. Pay special attention to the texts in the installation instructions and in the vehicle 's owner 's manual about coolant level, bleeding air, leakage and quantity of anti-freeze.
